Installation guide for a software update

MANUAL

Software version min. FST-2XT V2.000-xxxx

Doc. No. sw_update_FST2XT_2015_12_en

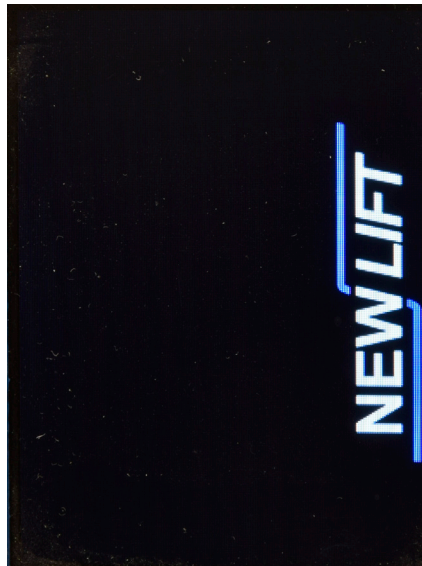
Fig. 1 Bootscreen

During the V2.000-0117 software update, parts of the FST operating system need to be also updated. In very rare cases, it is possible that the update will not be entirely successful, leading to the following failure scenario:

The FST boot screen appears (see example below), but the FST program does not start as expected. After a short while the screen will fade to white.

Unfortunately, there is no real solution to this problem, the board may eventually need to be sent to NEW LIFT for repair. The following workaround, will however, allow the board to be used until a replacement is available.

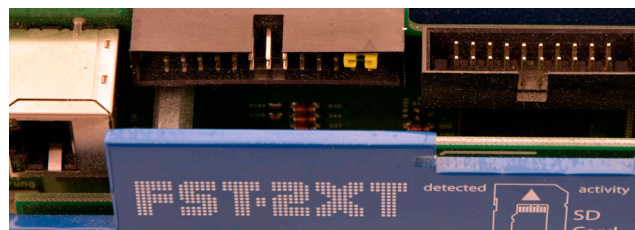
Fig. 2 Jumper is inseted

The disadvantage with this solution, is that the X9 serial interface will not function as long as Pin 1 and Pin 3 are bridged.

1. Turn off the power using the F4 breaker.
2. Take a spare jumper, and insert this between Pin 1 and Pin 3 of X7 (these are the two pins in the top row, right-hand corner. See Fig.2)

A suitable jumper would be J90 next to the X9 9-way Connector.

3. Turn the power back on. After approximately 5 seconds, the FST should start normally.
