FST2XT Software Change History

Issued by: NEW Lift Steuerungsbau GmbH

Release: FST V0183, 03.04.2024

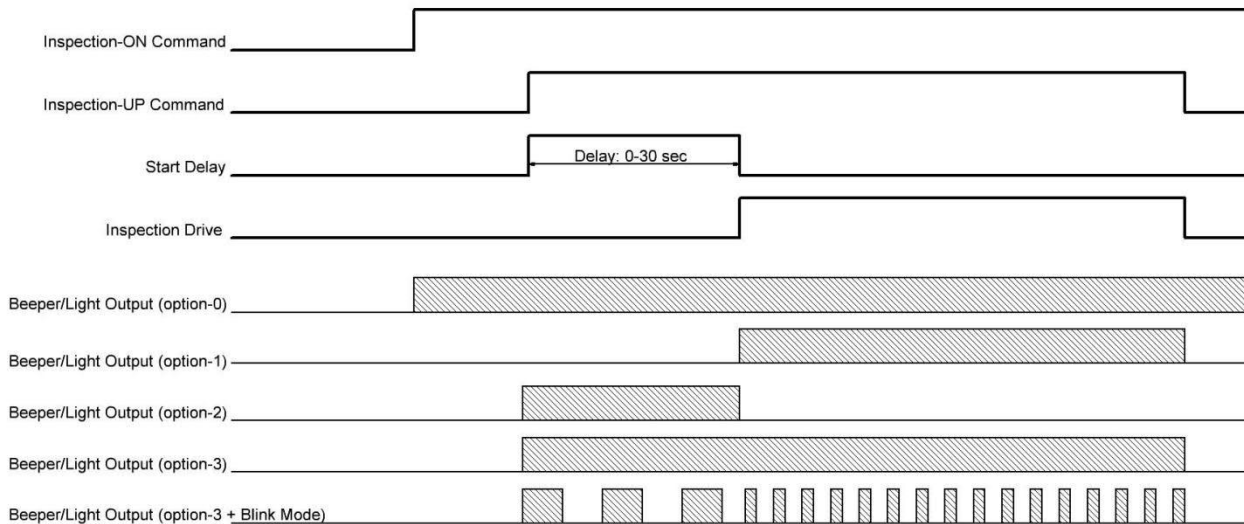
3) Inspection Start-Delay Option: new feature allows a programmable time to expire between the user activating a inspection drive and the actual drive. This facility is available separately for Up and DOWN

direction. A new Output Port is available for optical/acoustic signalling.

Menu: \ Configuration \ Inspection \ Start Delay Up = 0..30 (sec)

Menu: \ Configuration \ Inspection \ Start Delay Dn = 0..30 (sec)
