FST2XT Software

Change History

Issued by: NEW Lift Steuerungsbau GmbH

Release: FST V0174, 13.01.2023

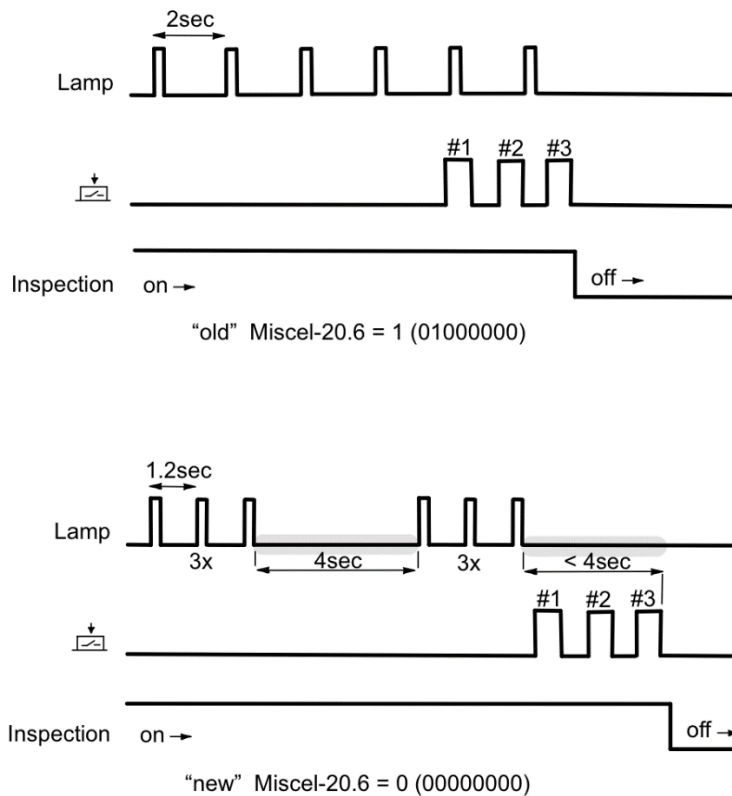
10) Pit Inspection Reset via Landing Call:

When using the bottom landing call button attached to an ADM/EAZ Module, the blink signalling pattern has been changed slightly to work with EAZ modules that cannot read the button input whilst illuminated. If required, the “old” method can be restored using Miscel-20.6
