FST2XT Software Change History

Issued by: NEW Lift Steuerungsbau GmbH

Release: FST V0157, 16.06.2020

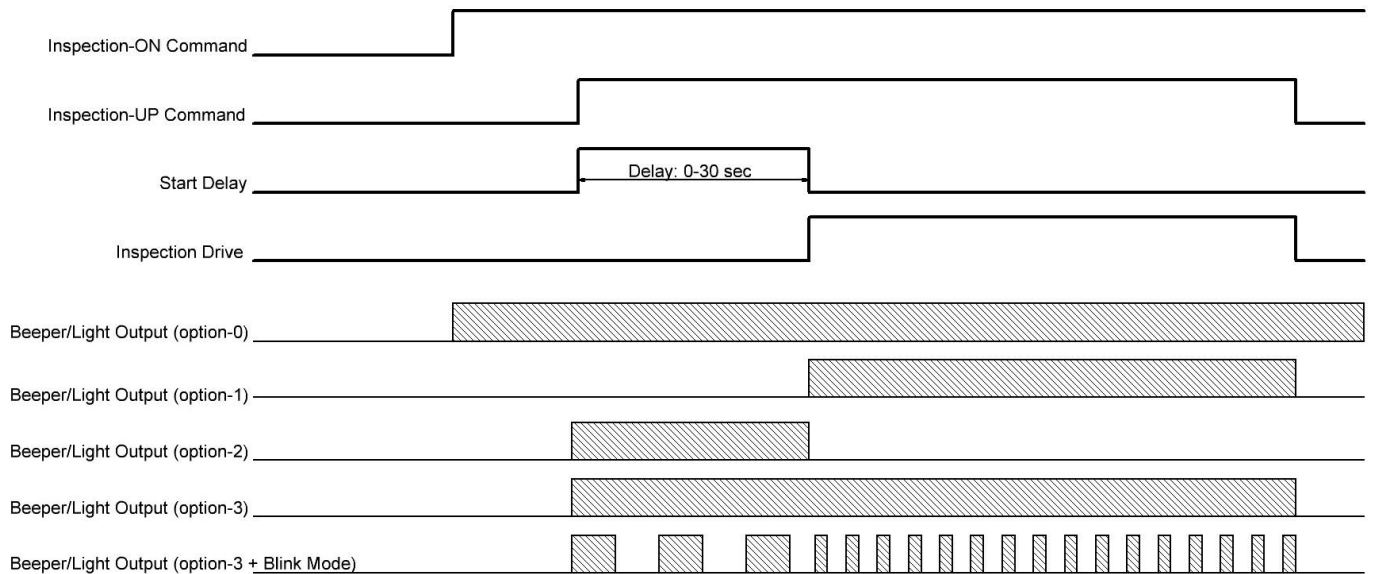
3) Inspection Start-Delay Option: new feature allows a programmable time to expire between the user activating a inspection drive and the actual drive. This facility is available separately for Up and DOWN direction. A new Output Port is available for optical/acoustic signalling.

Menu: \ Configuration \ Inspection \ Start Delay Up = 0..30 (sec)

Menu: \ Configuration \ Inspection \ Start Delay Dn = 0..30 (sec)
